# NY/NJ Harbor Dredged Material Management Plan

Study Areas: Norton Basin & Little Bay Pits

Reference Areas: Grass Hassock Channel & The Raunt

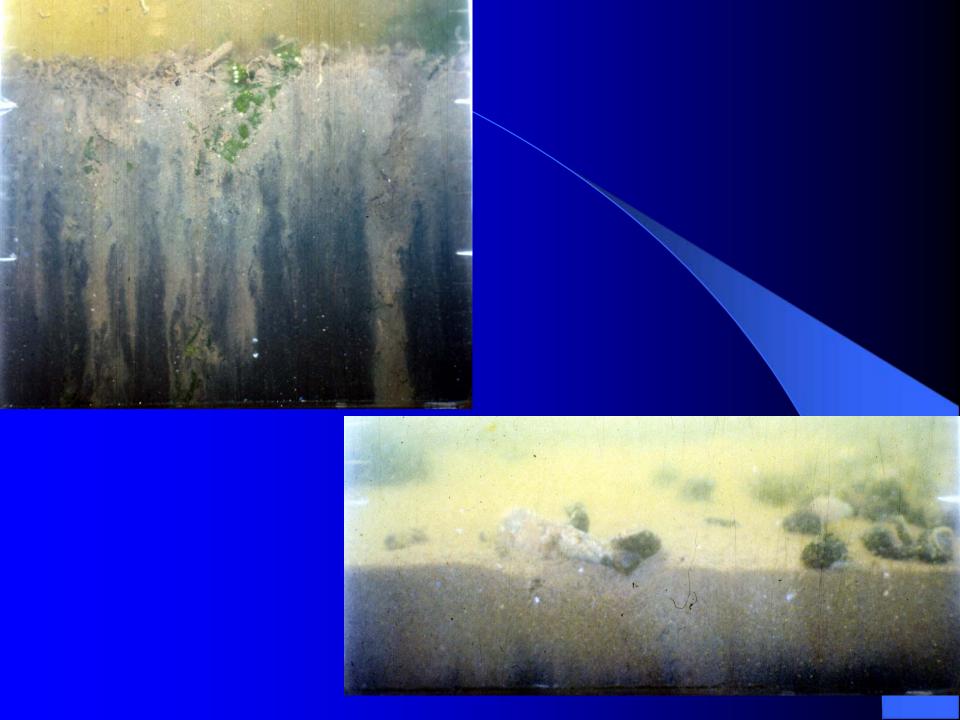
### The Raunt

Photo ra13 Sand and shell with hermit crabs

Photo ra15 Shell bottom transition to sand

Photo ral4 Amphipod mat

Photo ral6 Sand, patchy amphipod mat, hermit crabs

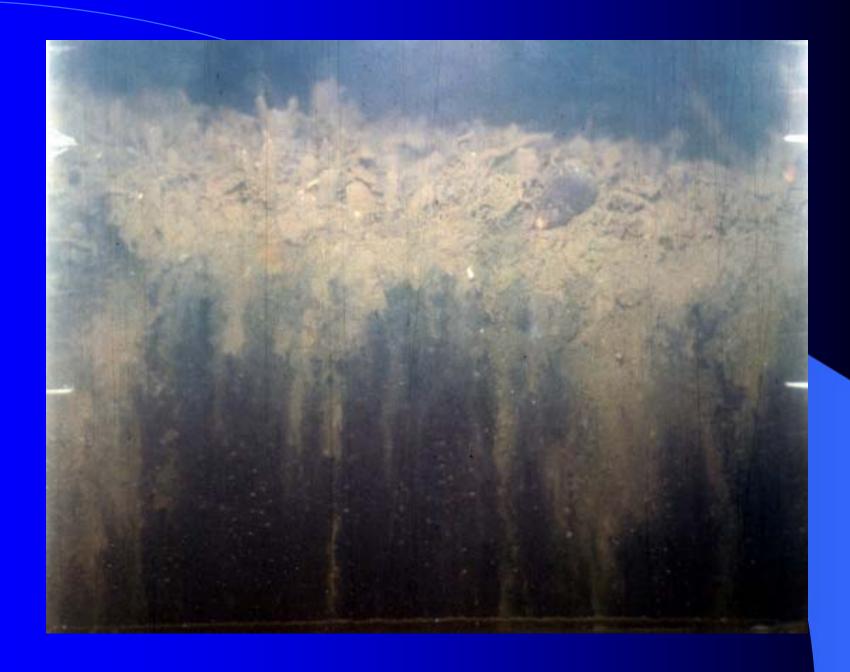
#### Grass Hassock

Photo gh9 Amphipod mat with algae

Photo gh11 Sand bottom, shell hash

Photo gh10 Amphipod mat with quahog

Photo gh12 Amphipod mat with quahogs

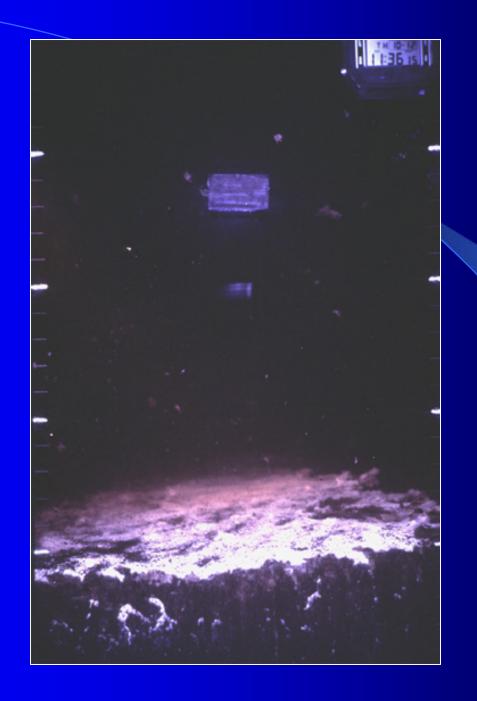
## Little Bay

Photo lb1 Soft black mud bottom

Photo lb3 Black mud with dead ulva

Photo Ib2 Black mud with dead ulva

Photo lb4 White bacterial mat on black mud

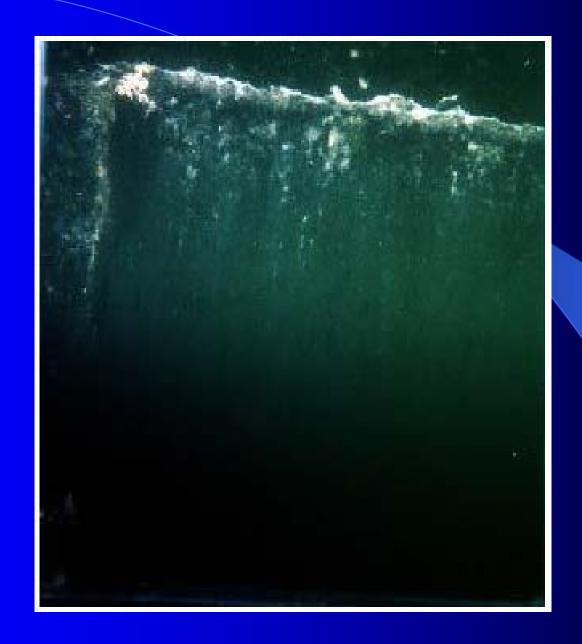
#### **Norton Basin**

Photo nb1 Black mud with shell hash

Photo nb3 Black mud and live Ulva

Photo nb2 Black mud with algae

Photo nb4 Bacterial mat on black mud
